**ALEUTIAN ISLANDS HOUSING AUTHORITY**  
**TRIP REPORT:**  
**ST. PAUL ISLAND, FALSE PASS AND KING COVE**  
**Assessment of Mold and Moisture Conditions**

**Final Report**

Date:  
August 16-20, 2004

*Prepared for:*  
U.S. Department of Housing & Urban Development  
Office of Native American Programs

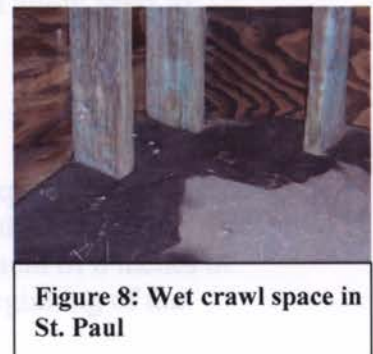
Poor site drainage typically results in wet foundations and the problems associated with them. The housing in St. Paul, False Pass and King Cove are not as susceptible to poor site drainage because the homes are separated from the ground beneath them by being either up on piers (with skirting) or having perimeter stem walls, neither of which are airtight. The floors are insulated and sealed on the bottom of the joists with plywood, keeping moisture beneath the homes less a concern than with conventional construction. However, particularly in St. Paul where the perimeter stem walls were tighter than the pier foundations in False Pass or King Cove, it is still not desirable to expose the bottom side of the belly-board to high humidity. Figure 8 highlights moisture problems beneath one of the homes in St. Paul.

Although not as critical as in standard construction, the following discussion regarding site drainage still applies to housing in St. Paul, False Pass and King Cove.

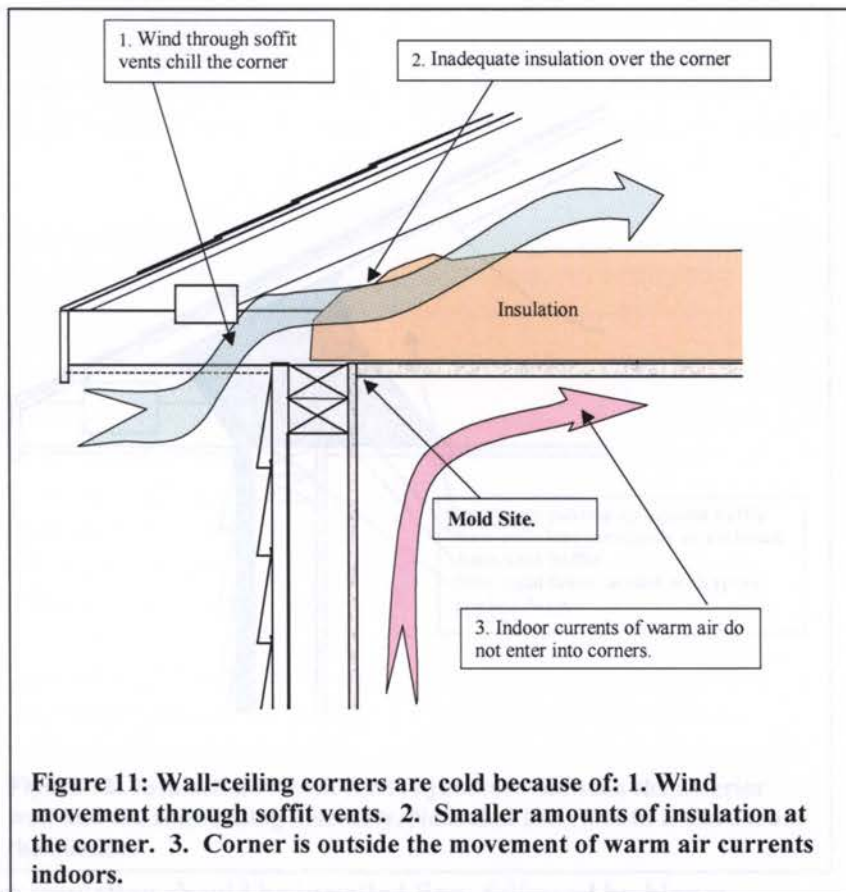
Three reasons why the exterior wall/ceiling juncture becomes cold follow (Figure 11):

1. Cold wind entering through soffit vents and passing through the porous insulation material, degrading its thermal performance.
2. Poorly installed insulation resulting in reduced amounts of insulation in the corners.
3. The geometry of the corner may prevent slow-moving currents of warm air from reaching into the corners.

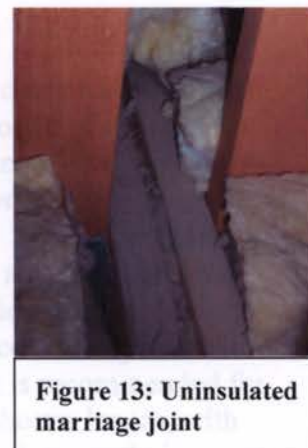
Most homes in the Aleutians consist of two modular units fastened together at the centerline of the home. The longitudinal marriage joint between the two modular units was a common location for mold at the ceiling. This is a location where structural members are fastened together. Figure 13 illustrates the marriage joint from in the attic and although everything around the marriage joint appears well insulated, it reveals that the structural members are not insulated causing a thermal bridge along this particular junction. To resolve the mold problem on the interior, insulate this junction in the attic with fiberglass insulation. Lay the insulation over the top of the lumber and ensure it is also between the vertical truss members on each side of the horizontal members.

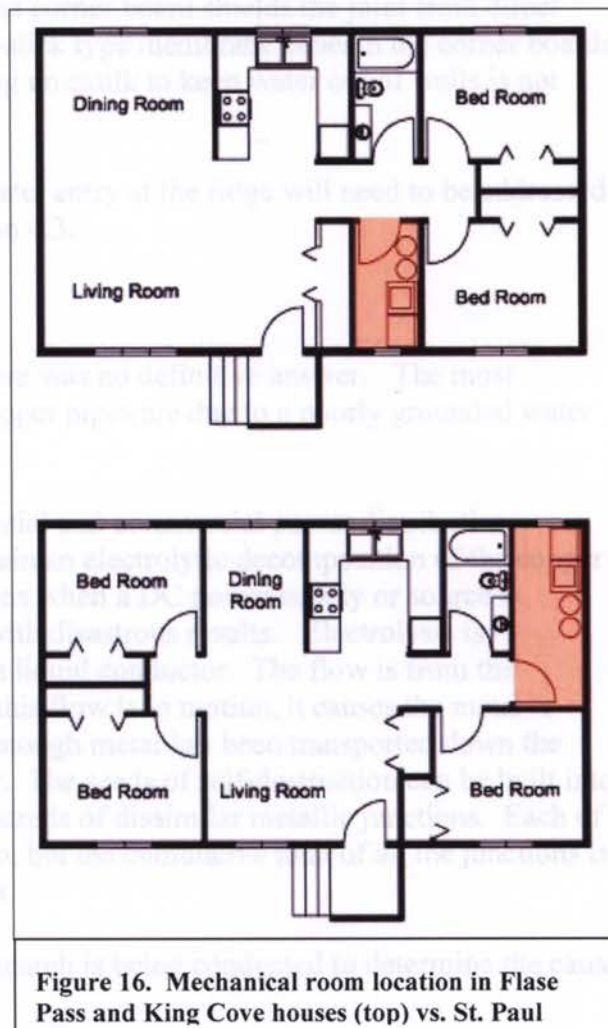
Figure 16. Mechanical room location in False Pass and King Cove houses (top) vs. St. Paul

Homes in St. Paul tended to have hotter, more humid mechanical rooms than homes in False Pass or King Cove. In all cases, occupants tended to keep these rooms closed off, in large part because of these conditions. The difference in conditions between the villages is likely due to the location of these rooms (Figure 16). In St. Paul, these rooms were at the end of the home, with half of the walls being insulated outside walls.

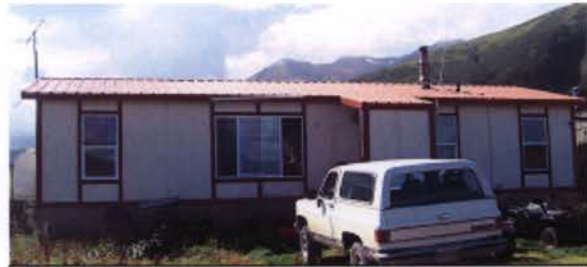
Figure 1: False Pass; Front Elevation

**Mold and Moisture Conditions:** Minor mold growth appeared on the attic roof sheathing, but little mold appeared in the rest of the home. Plumbing leaks contributed to a wet interior.

1. Repair the toilet, tub, and kitchen sink plumbing.
2. Currently the boiler in the mechanical/laundry/storage room obtains combustion air from the attic. Reconfigure so the combustion air is taken directly from the exterior. Any time the pressure inside the mechanical/laundry/storage room is greater than the attic, warm moist air can freely migrate into the attic space. This is probably the source of moisture that has caused minor mold growth on the attic sheathing.
3. Cut back the drywall behind the toilet and adjacent to the tub up to the undamaged material. Inspect the interior of the wall for damage, repaired if necessary, and close it back up.
4. Replace the range hood recirculating exhaust fan with one that vents to the exterior.
5. Check and repair the dryer exhaust.

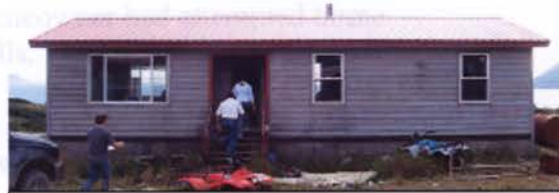
Figure 1: King Cove; Front elevation

**Mold and Moisture Conditions:** This vacant unit contained much of the prior owners' personal goods. Frozen plumbing and subsequent flooding of the home occurred in the owners' absence. Mold on the walls resulted from the flooding (Figures 2 & 3). Also mold at the wall to ceiling junction at two-feet on center was present (Figure 4).

1. Remove personal possessions.
2. Clean moldy drywall. In areas where the paper face of the drywall has been compromised, remove the drywall, inspect interior of wall, repair as needed, and redrywall.
3. Repair the kitchens sink plumbing and cabinet.
4. Replace the range hood recirculating fan with one that vents to the exterior.

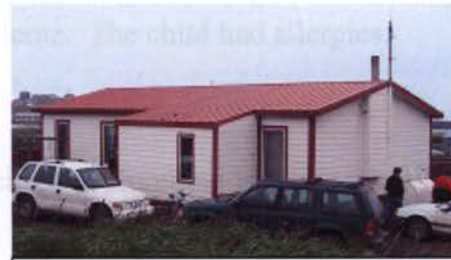
Figure 1: St. Paul - 610; Front Elevation

No gutter system was present. The site at the front of the home drained toward the home (Figure 1).

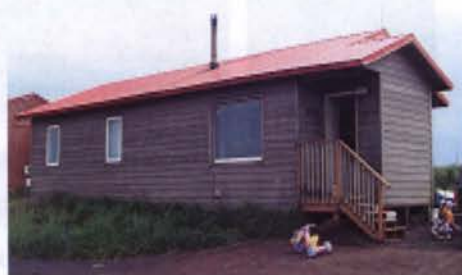
Figure 1: St, Paul Island; Front elevation sloped away from home

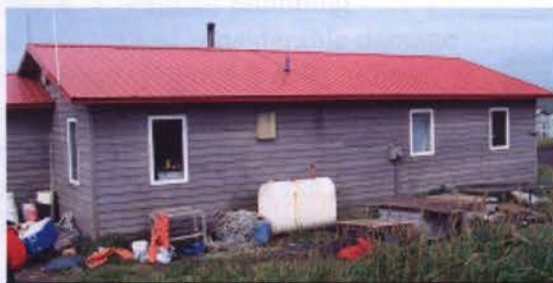
Figure 2: Flat rear elevation
